Project

Broken Ridge is a 44 ha site located on the Coast Road 3 km south of Suffolk Park and about 9 km south of Byron Bay. The site was acquire, rezoned and developed by the White, Bourke and Stone families.

Brief outline

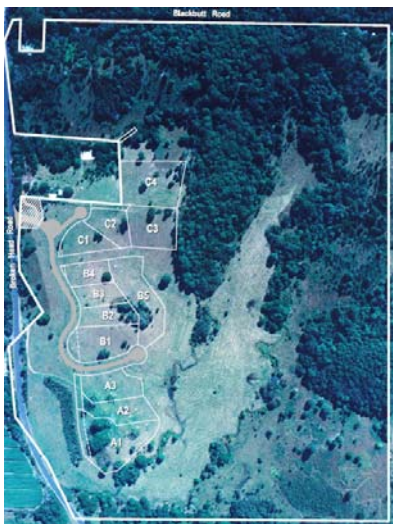
has been designed to strictly accord with the exacting provisions of that Strategy. It is a **Community Title subdivision for 12 rural lots, located in 3 distinct clusters and 1 neighbourhood association lot containing all of the roads, services and site rehabilitation works.**

All the proposed dwelling lots are clustered within the cleared part of the site west of Midgen Creek. All existing vegetation is retained, vegetation corridors actively extended throughout the site and have been
